THE DESIGN OF CROSS-LAMINATED TIMBER SLABS WITH CUT-BACK GLULAM RIB DOWNSTANDS – FROM RESEARCH TO LIVE PROJECT

ABSTRACT: A research project was undertaken to investigate the behaviour of composite CLT slabs with glulam downstands cut back from the supports. A desk study and Finite Element Modelling (FEM) were used and evaluated on their ability to model and design such a structure, focusing on the cut back location and utilising reinforcement screws. The project included full-scale laboratory testing of a composite slab to failure with innovative data collection techniques such as Particle Image Velocimetry. A similar structural element was also used in a real construction project and the investigation gave insight towards its design. It was concluded that the embedment depth of reinforcement screws in the glulam downstand is key to the performance of the composite slab with full depth penetration advisable. FEM can give useful results for stress concentrations in the timber and a simplified design method was proposed.

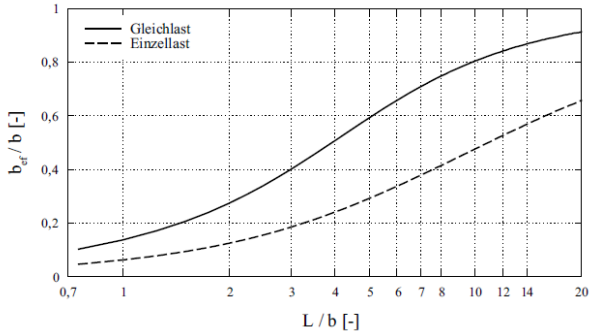
Figure 2: Effective width design chart for CLT ribbed slabs-top curve for mid-span, bottom curve for support calculations [1]

As per the design of T-beams in other more conventional materials e.g. reinforced concrete, the concept of the effective slab width, b_{ef} , needs to be considered as a result of shear lag. This is introduced for CLT ribbed slabs in [1] and provides an approximate reduced slab width to be used when calculating the design stresses and deflections due to the non-uniform normal stresses in the slab. See Figure 1 and Figure 2 below.

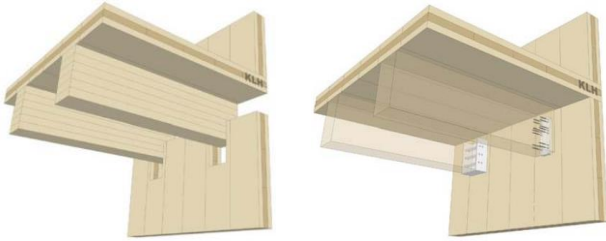
Figure 7: Non-preferable support conditions - castellated walls (left), shear connection (right). (credit K LH)

Additionally, not having the ribs continue to the supports makes the actual support construction very simple. As only the slab needs to have direct bearing, the support needs only be a flat surface which is the most common scenario in the platform construction method usually adopted for CLT structures. Otherwise, should support be required for the ribs, a castellated arrangement needs to be provided or complex shear connections at each rib location made to the supporting structure. This is illustrated in Figure 7 below.

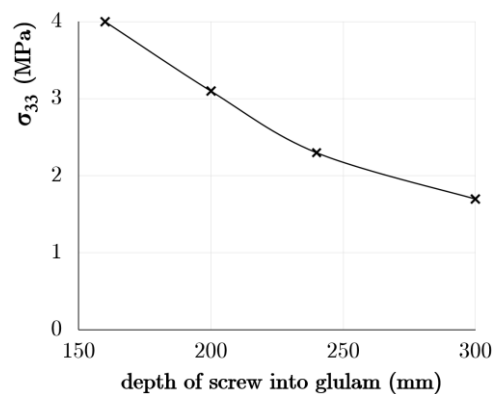
Figure 19: Peak σ_{33} at screw tip for different lengths of screw i.e. penetrating deeper into the glulam rib

This σ_{33} stress was again much higher than the tensile timber strength perpendicular to the grain according to the Eurocode. The screw depth was varied in the FE model to investigate its effect and whether reaching the 0.5MPa strength suggested by the Eurocode is possible. The stress concentration relocated at the screw tips at every iteration but reduced in magnitude as shown in Figure 19 below. Even at double the initial depth, the stress did not drop below 1.5MPa.

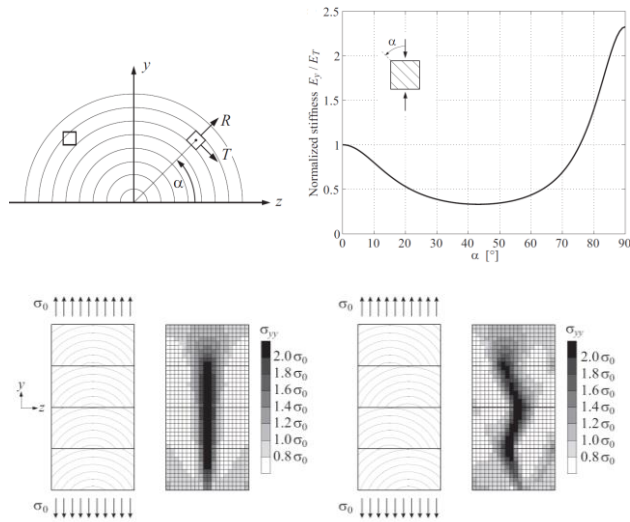
Figure 29: Stiffness and stress variation of timber dependent on the angle of the growth ring orientation (from Danielsson [5]).

The low magnitudes of the strains were common to both the PIV results and the strain gauges. After conducting some further literature review, it was suggested that the stiffness of timber perpendicular to the grain is greatest when the growth rings are perpendicular to the stiffness direction [5]. FE modelling of this behaviour illustrates that the stresses in the middle of the growth rings can be twice as high as at 45° which is similar to the orientation of the growth rings at the sides of the glulam ribs (see Figure 29). A further consideration why the PIV strains at the corner location are low could be due to the smoothing algorithm in the Matlab code that does not work as well near boundaries. The strain gauge can only provide an average over its length that, in turn, could make it unable to return the high localised corner stresses.

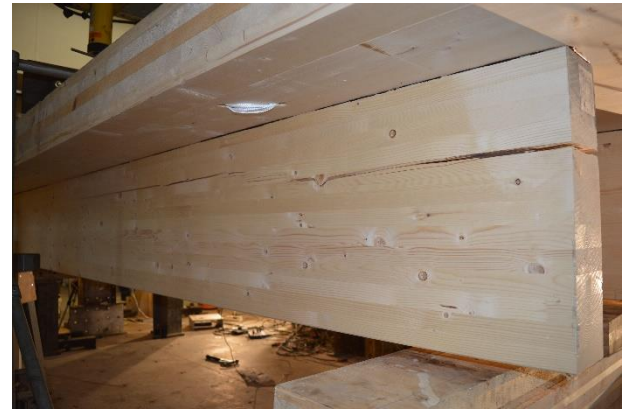
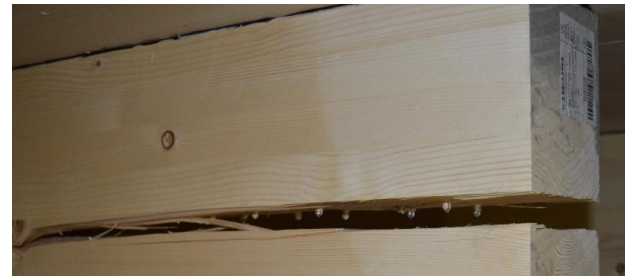
Figure 30: Failure mode of CLT ribbed slab test sample by splitting at the screw tips

The test was again a 3-point bend and failure occurred at a total applied load of 236kN by the splitting of 2 glulam ribs at the tips of the screws (see Figure 30 below). This confirmed the expectations that identified that there were high stress concentrations in the timber at the screw tips which were higher than the timber strength perpendicular to the grain.

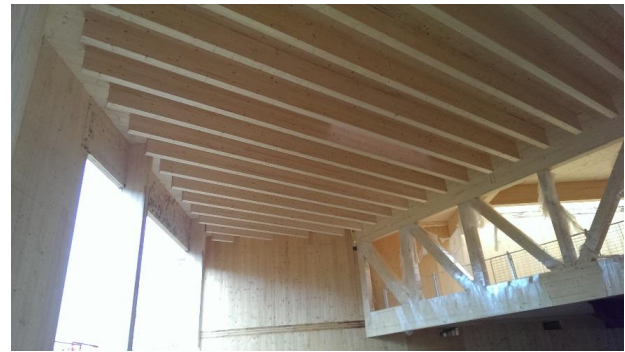
Figure 32: CLT ribbed slab with cut-back glulam ribs as built in GPUTC

A CLT ribbed slab was specified to form the ceiling of a column-free “events space” due to the long-span requirements of 11.5m (see Figure 32 below) and its use as a transfer structure. Similar to the research project, the glulam ribs were stopped short from the supports to allow services to run through and to allow the CLT deck to bear directly on top of a long-span timber truss. It was not possible to adopt a castellated support as this would have taken out most of the truss top chord and if direct shear connections were specified for the end of the ribs, then some of them would clash with the internal steel plate truss connections.
